Durofix RV332 Bit Chuck Replacement

This guide will demonstrate how to properly replace a defective bit chuck on the Durofix RV332 Cordless Li-ion Screwdriver.

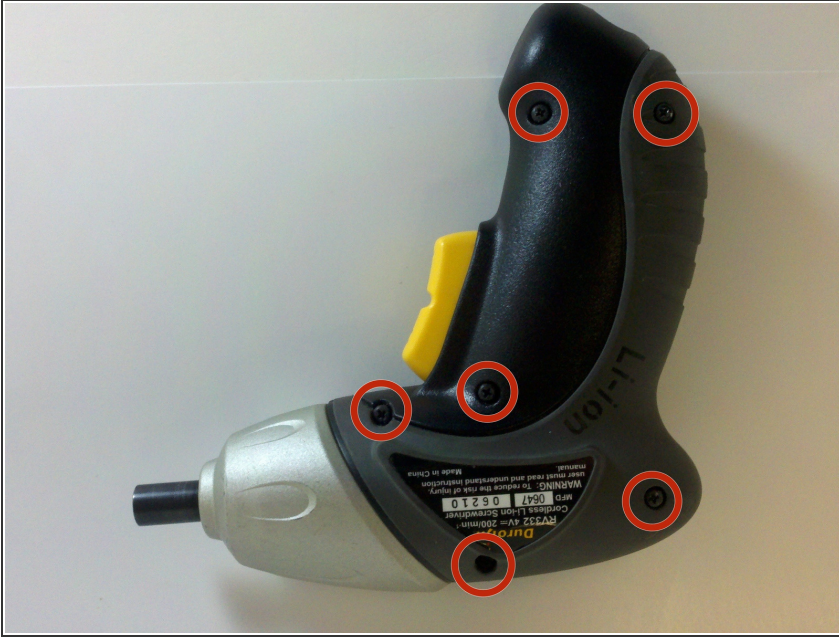
Step 1 — Bit Chuck

- Remove the six 13 mm casing screws with the #0 Phillips screwdriver.

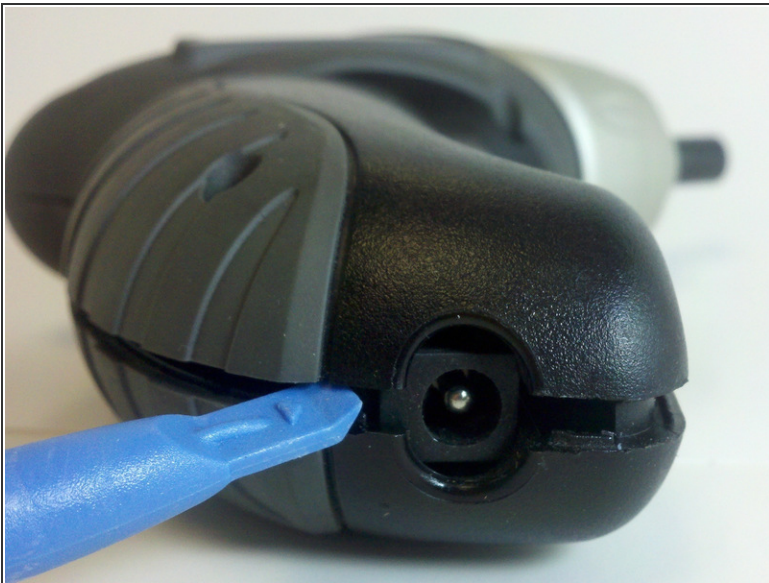
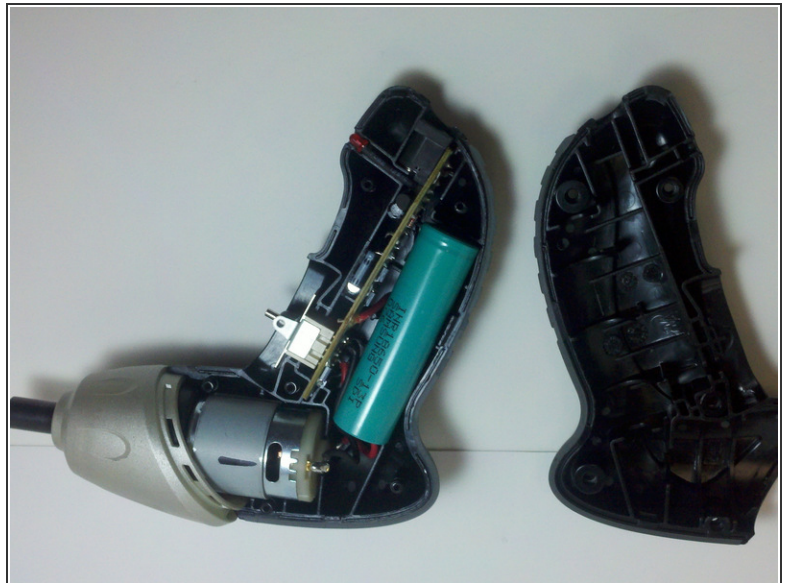
Step 2

- Separate the screwdriver casing halves with the plastic opening tool.
